Software Update Notification

PSS0002-31: Mastersizer 2000 v5.60 software

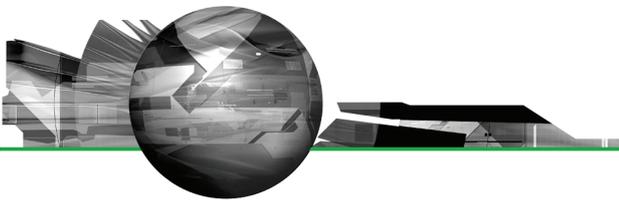
Instrument compatibility

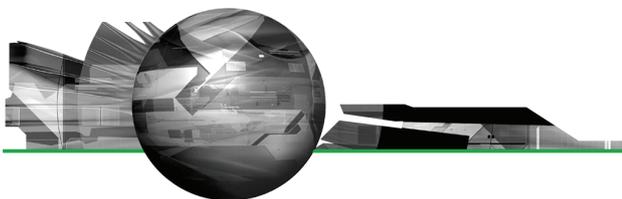
Full details of the 21 CFR Part 11 features available within the Mastersizer 2000 software can be found in the following documents included on the Mastersizer 2000 software CD-ROM:

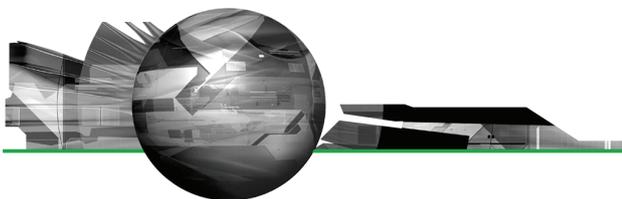
7487	The advice links for the SOP pages do not seem to work.	Bug	Fixed
7609	[CFB 00748] The code for ignoring the first result for dry powder measurements causes strange SOP values to be recorded.	Bug	Fixed
7713	Some of the help buttons do not function correctly.	Bug	Fixed

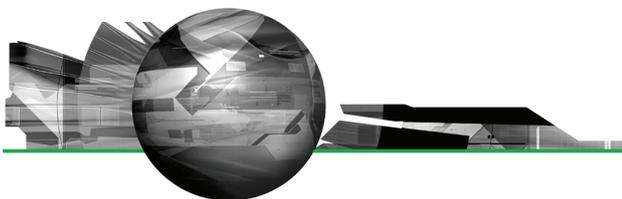
Upper Size Limits and Dv100 reporting

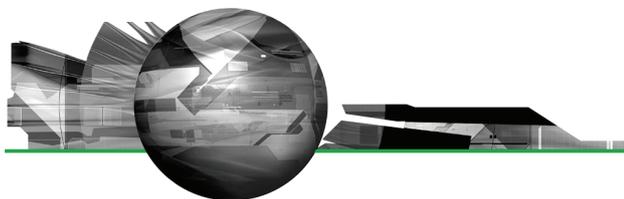
The Lactose refractive index listed in the Mastersizer 2000 particle property database (1.347) is incorrect. The correct value for Lactose should be between 1.52 and 1.54. The entry has not been changed, as this could affect existing methods. If users wish to use the correct value, they are requested to set up a new entry in the software's particle properties database.
